SCHAEFER
Inspection Service, Inc

Confidential Inspection Report
123 Main Street
Woodbridge, CT 06525

Prepared for: John & Mary Smith

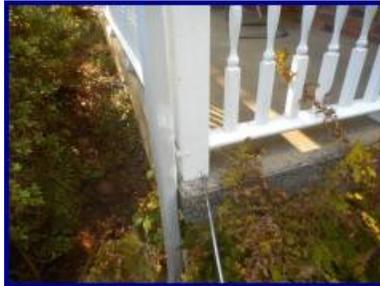
Monitor: support posts for porch roof show minor softness at their bases, future repair will be needed.

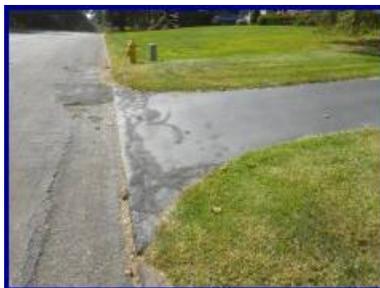
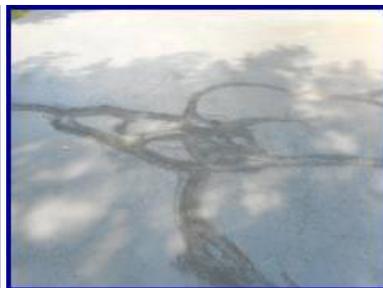
Cracks noted are common. Applying driveway sealer may help lengthen life span of driveway.

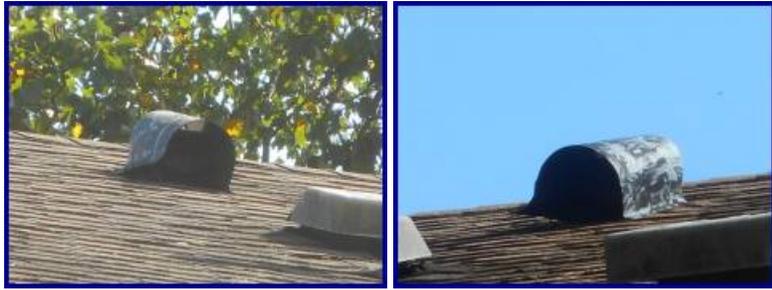
- The unusual vent termination in the rear roof that appears to be connected to the kitchen stove vent should be checked and reconfigured if necessary.

Further evaluation and correction, if needed, by a qualified roofing contractor recommended:

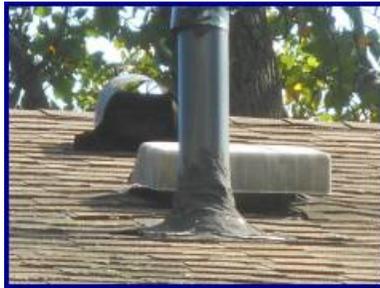
Attention: The waste pipe flashing was covered with roof cement. This is typically done because leakage occurred and this is an easier way to seal around the pipe rather than re-flashing. Roof cement will become brittle with age and possibly crack, leaving openings for water intrusion. Monitor this area and maintain roof cement or re-flash waste pipes.

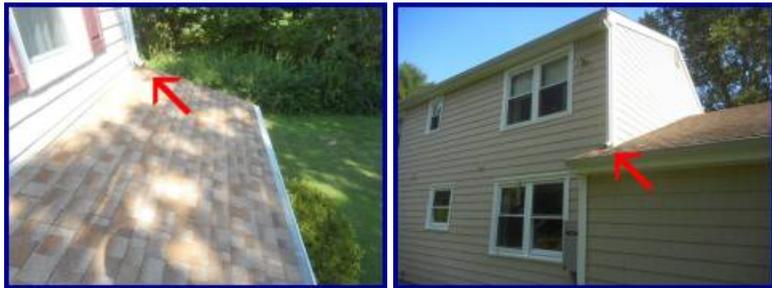
Attention: It is best not to allow leaders from an upper roof to empty onto a lower roof. The water flowing from the leader can erode and damage shingles over time. The installation of an additional lead section to carry water to the lower gutter is recommended.

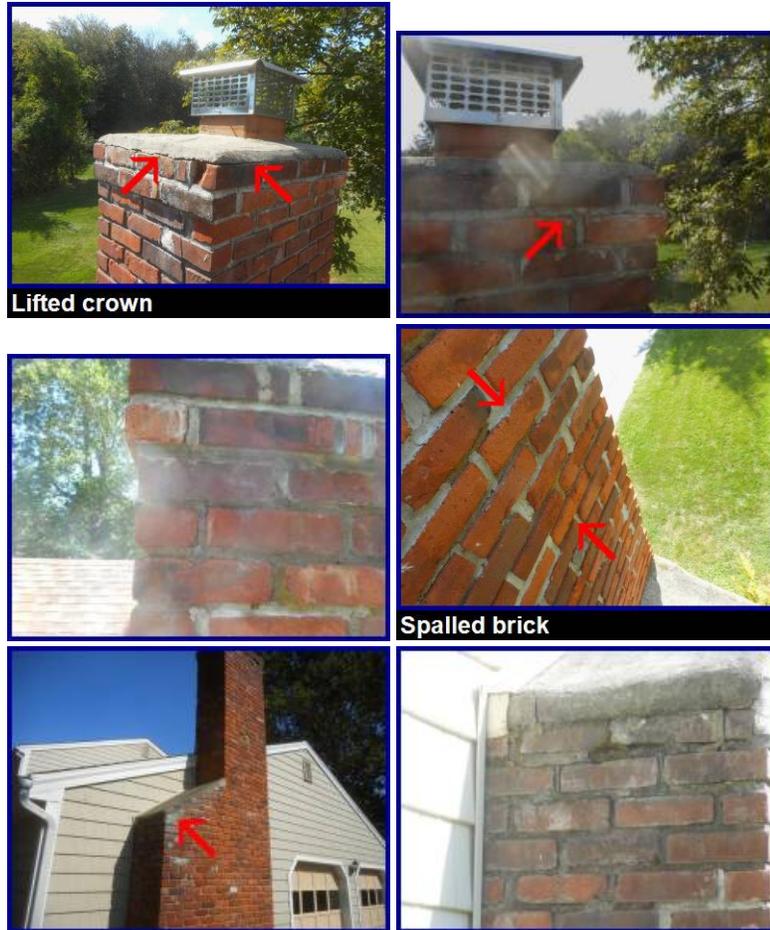
- **Left side chimney:**
- **Cracks in chimney crown. Not correcting these cracks can lead to additional damage from seasonal moisture freeze and thaw.**
- **Deteriorated, loose, or missing mortar observed. Pointing is needed (joint repair).**
- **Damaged brick and spalling was noted, seller should be asked if chimney brick has been sealed against water absorption.**

- Chimney shoulder needs repair.

Further evaluation and correction by a qualified chimney sweep or mason is recommended:

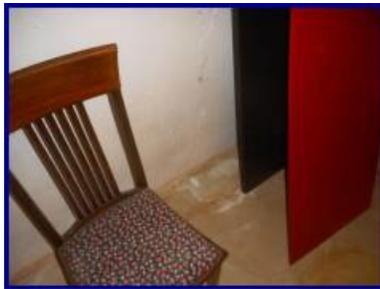
Dry stains often indicate past water intrusion. It is not within the scope of this inspection to determine if observed stains are an indicator of future water intrusion. The seller should be questioned to obtain the history of this issue. If information received from the seller is not adequate that water intrusion has not occurred in the house in many years, we recommend contacting a basement waterproofing company for further evaluation. It should be noted that a house can go for many years without water intrusion and still leak at a future date. There is no way to guarantee water intrusion will never occur. Dry stains were observed in the following area(s): Slab.

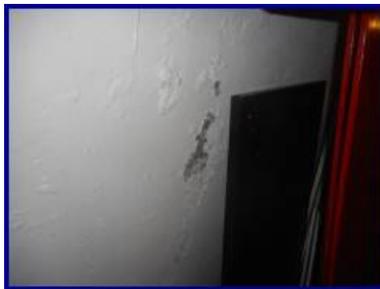
Efflorescence is a white powdery substance often seen on foundations and basement slabs. It is the result of moisture absorbing into the concrete and dissolving soluble salts that then appear on the surface. It is an indication of some moisture intrusion. Very often efflorescence is present without any actual visible water but because it does indicate moisture, some improvements should be considered. An improved slope away from the foundation, extensions on down spouts, and a dehumidifier may help reduce efflorescence. Ongoing monitoring is also advisable to determine if other moisture intrusion occurs under various weather conditions. Efflorescence was observed in the following area(s): On foundation walls.

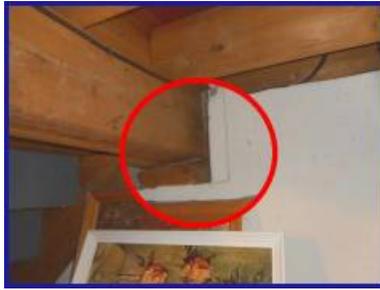
- The main carrying beam has rotated and may not be adequately supported at the foundation. Sheet rock cracks and door problems noted on the 2nd floor may be a symptom of this problem.

Further evaluation and correction by a qualified contractor is recommended:

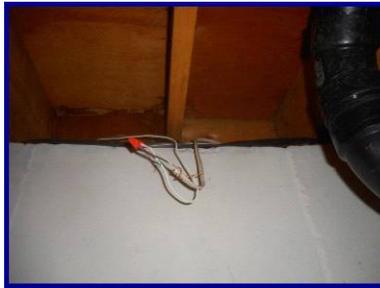
Wiring in basement

<i>Branch Circuits:</i>	The following wire types were observed in the house: Copper. Types of wire insulation included: Metallic, often referred to as "BX" and Nonmetallic-plastic, often referred to as "Romex"
<i>Branch Circuit Conditions:</i>	Further evaluation and correction, if needed, by a qualified electrician recommended: <ul style="list-style-type: none"> • Unusual wiring above rear foundation wall should be evaluated and repaired if needed.

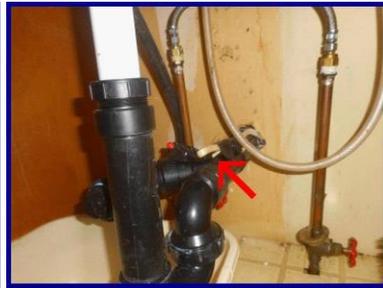
Under kitchen sink

- Open or exposed wire ends observed in the following areas: under kitchen sink.

Correction recommended:

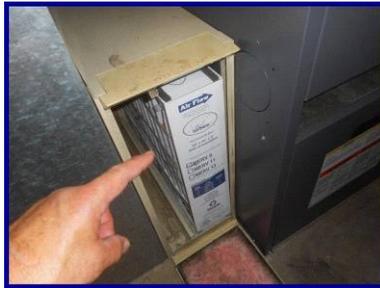
- Air filter was not properly installed in furnace which allowed unfiltered air to enter furnace and move through the cooling core for the AC. The core should

Filter is too small for filter rack

Further evaluation and correction, if needed, by a qualified HVAC contractor recommended:

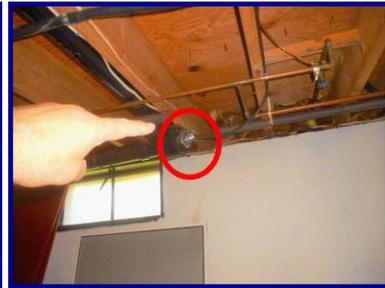
- be evaluated and cleaned if needed.
- The condensate drain for the AC is improperly connected to a waste pipe in the basement.

Condensate drain connection

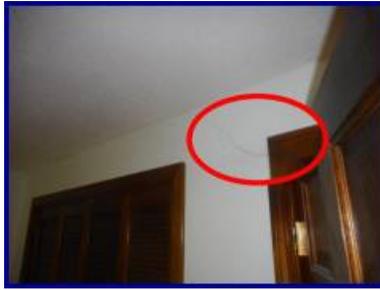
Wall Conditions: **Monitor:** There were cracks that appeared larger than commonly observed in the following areas: second floor left bedrooms.

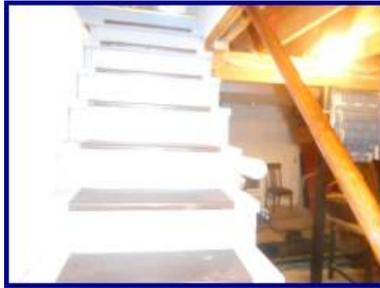
- Basement stair is not child proof.

Correction recommended:

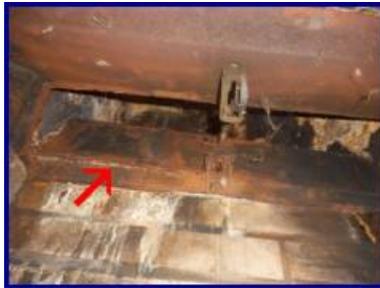
Correction recommended: The smoke shelf (area behind damper) has collected debris and should be cleaned before use in the fireplace.
