SCHAEFER INSPECTION SERVICE

COMMERCIAL - SCHAEFER COPY

1234 Main St.

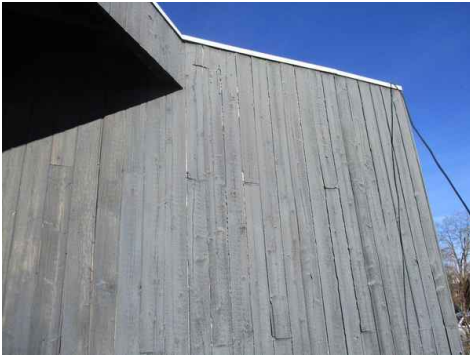
2.1.2 Siding, Flashing & Trim

NEEDS PAINT

Correction: Finish on exterior coverings is at or past the time for painting or stain. Maintaining the exterior finish is important to protect it from damage.

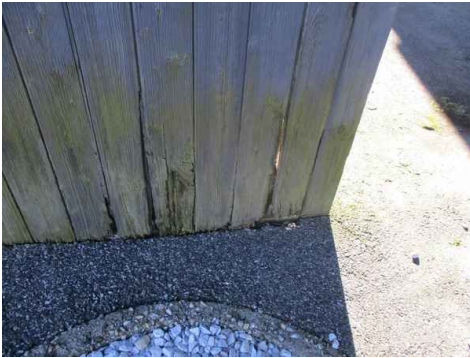
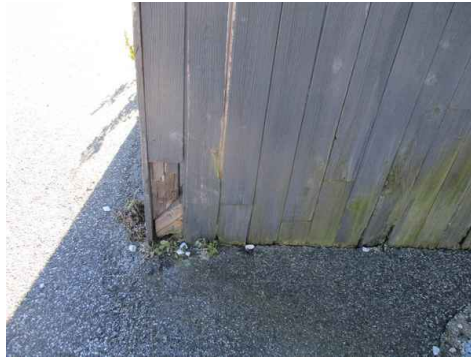
2.1.3 Siding, Flashing & Trim

ROTTED SIDING

Evaluate and Correct: Siding is softened and/or rotted from moisture at rear stairs. When siding is rotted on the surface, there is potential for additional decay on underlying components.

Contact a qualified professional.

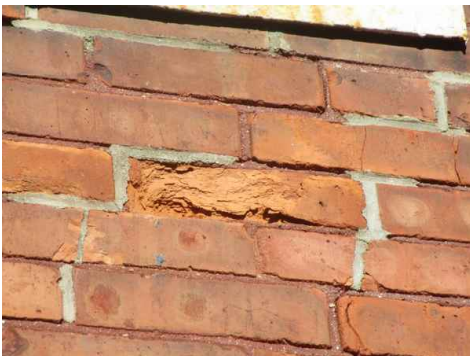
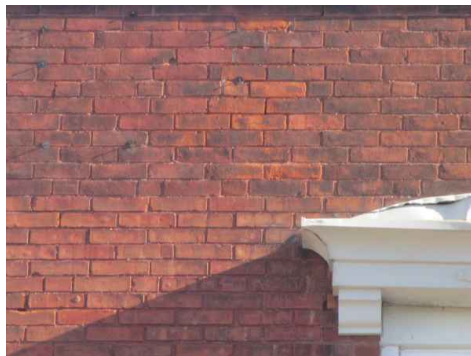
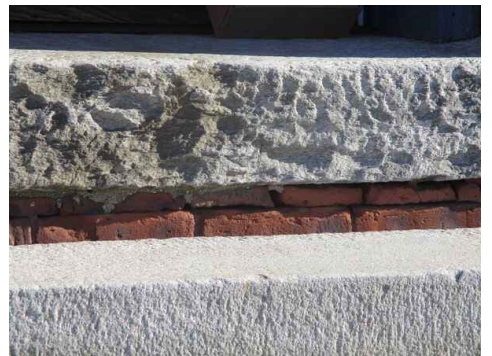
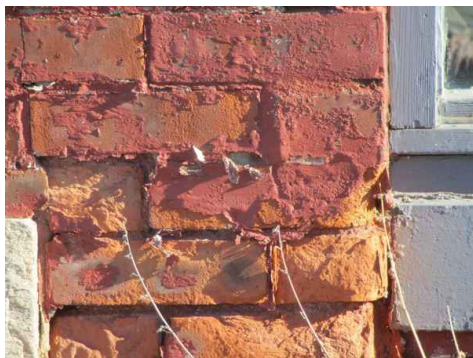
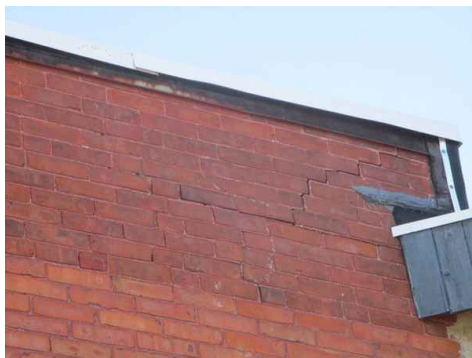
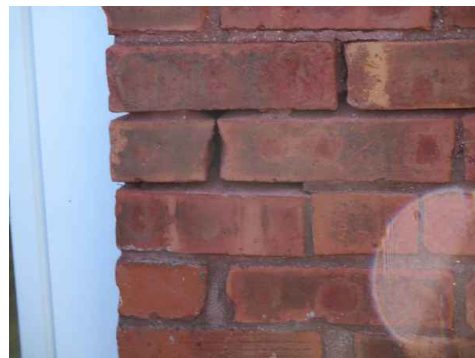
2.1.4 Siding, Flashing & Trim

BRICK DEFICIENCIES

Deficiencies such as spalling, missing mortar at joints, bowing, cracked, settled, detached, rusted or expanded lintels were observed on the brick exterior. Further evaluation and/or repairs by a qualified mason are recommended.

Contact a qualified masonry professional.

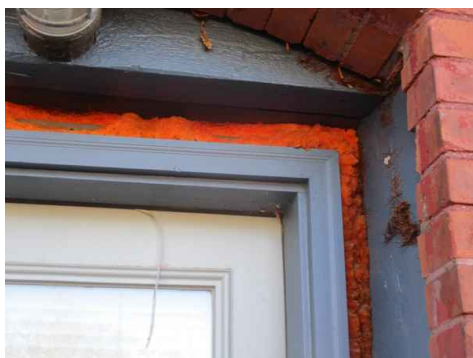
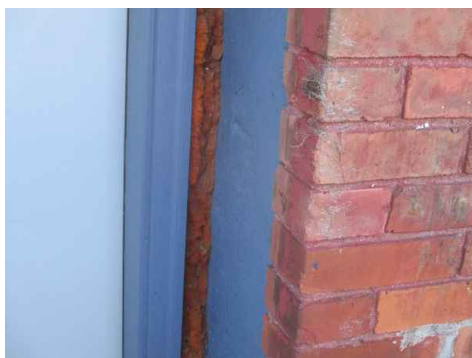
2.2.1 Exterior Doors

MISSING DOOR TRIM

Correction: Trim missing at left side door near retaining wall. Installation/replacement is recommended.

Contact a qualified professional.

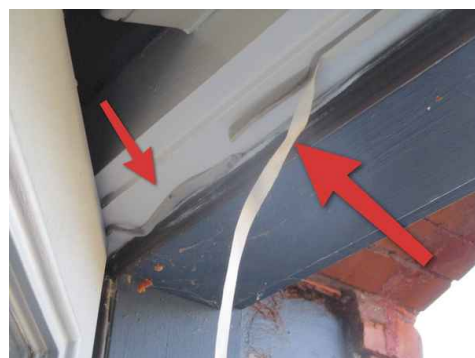
2.2.2 Exterior Doors

WEATHER-STRIPPING NEEDS REPLACEMENT

Correction: Exterior door weather stripping needs repair/replacement to make the door weather resistant. Outside air and moisture should not be able to enter.

Contact a qualified professional.

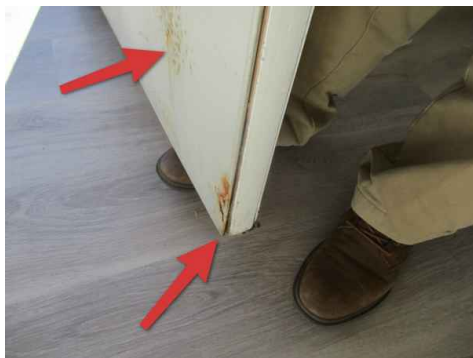
2.2.3 Exterior Doors

DOOR RUST

Correction: Exterior door observed has rust or is rusted through and will need replacement soon.

Contact a qualified professional.

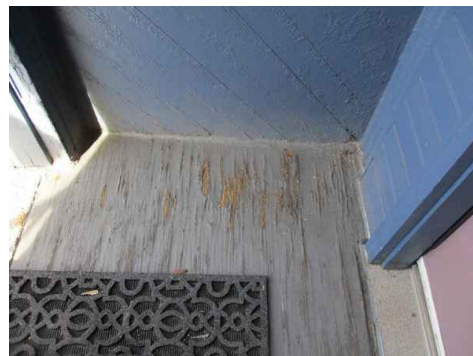
2.2.4 Exterior Doors

FRONT STOOP NEEDS PAINT

Correction: The front entry stoop needs paint to prevent water damage.

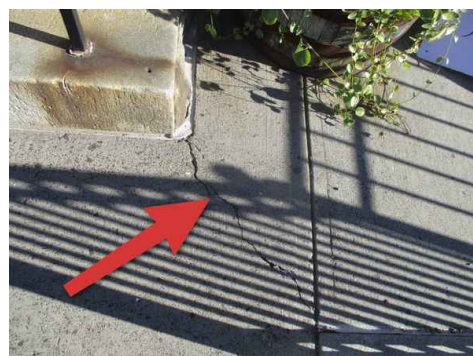
2.3.1 Walkways, Driveways/Parking Lot

WALKWAY CRACKING - MINOR

Minor cosmetic cracks observed. Recommend monitor and/or patch/seal.

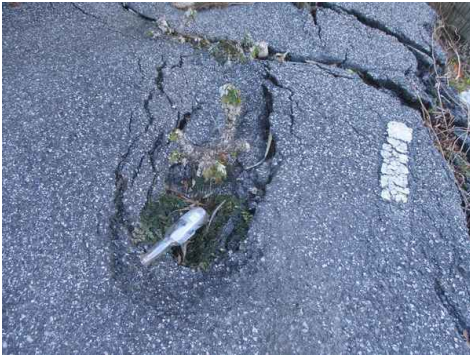
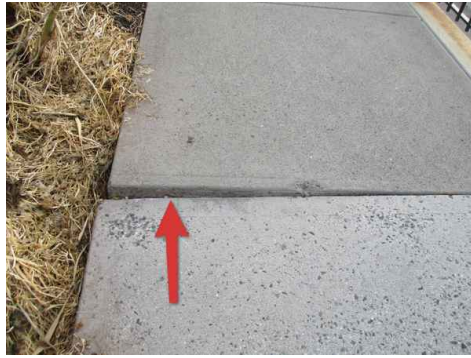
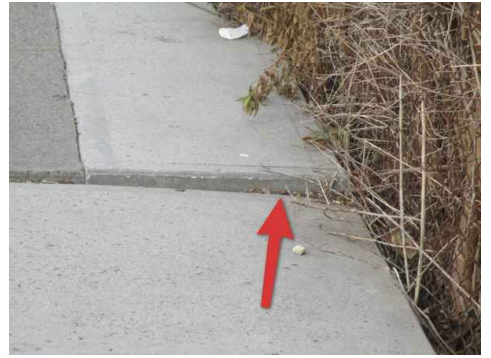
2.3.2 Walkways, Driveways/Parking Lot

SETTLED PORTIONS

Some areas of the parking lot and front walkway were settled or heaved and are trip hazards. Recommend a qualified contractor evaluate and repair, resurface, or replace for safety.

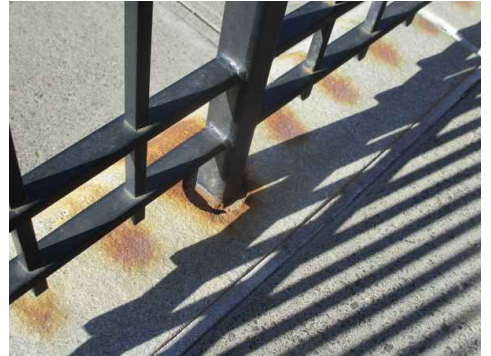
2.3.3 Walkways, Driveways/Parking Lot

RUSTED RAILINGS

Attention: Rust removal and painting to prevent deterioration is recommended for the rails.

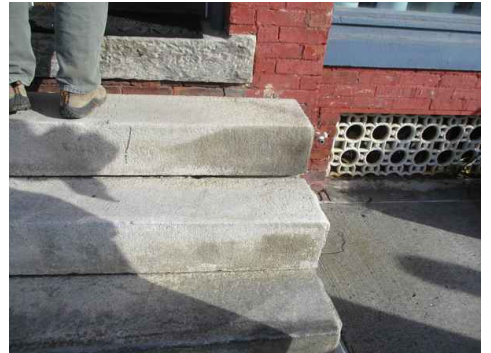
2.3.4 Walkways, Driveways/Parking Lot

NO RAILINGS

Correction: Installation of rails for safety is recommended at the front entry steps.

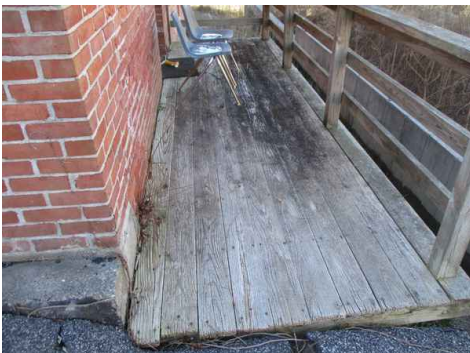
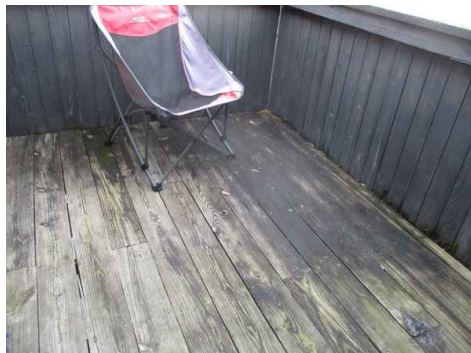
2.6.1 Deck

FINISH BAD

Attention: Decking planks were weathered. Refinishing is recommended.

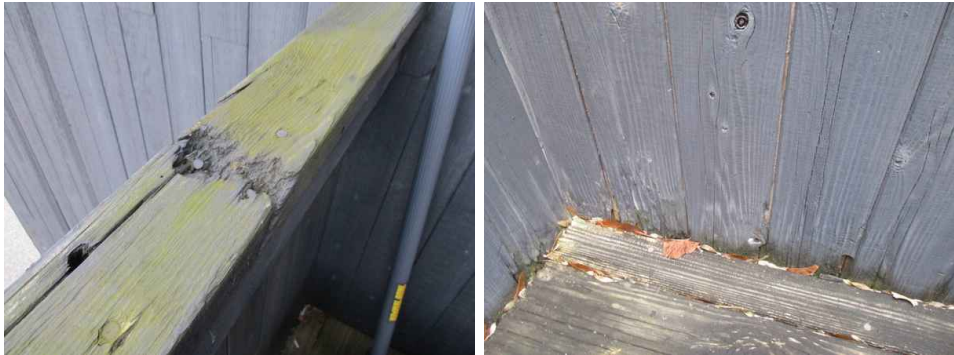
2.6.2 Deck

ROTTED RAILS AND/OR POSTS

Correction: The deck railings and/or posts are rotted and will need replacement soon.

Contact a qualified professional.

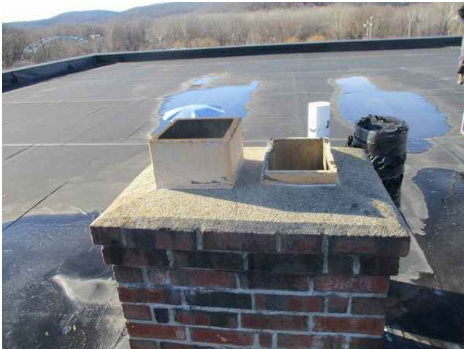
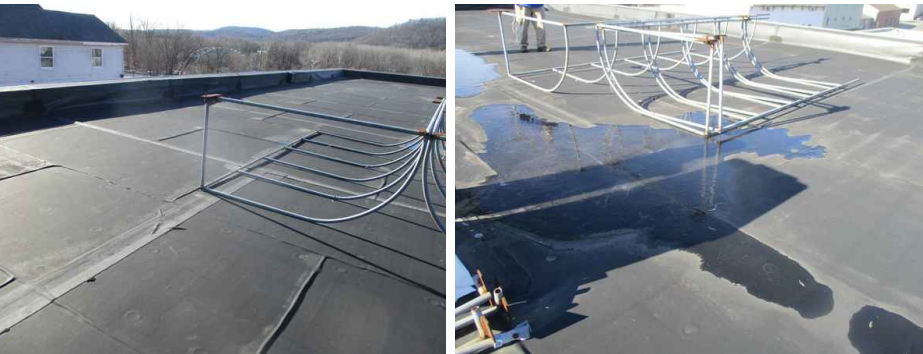
General Photo(s) of Roof

Inspection Method Roof	Roof Type/Style Flat	Estimated Age 10-15 Years It was disclosed that the roof was replaced in 2009.
Estimated manufacturer's represented life expectancy 20-25 years	Roof Materials EPDM Glued	Estimated Layers 1 visible layer
Gutter Materials Built-in	Flashings Material Aluminum	Chimney Type Present Brick

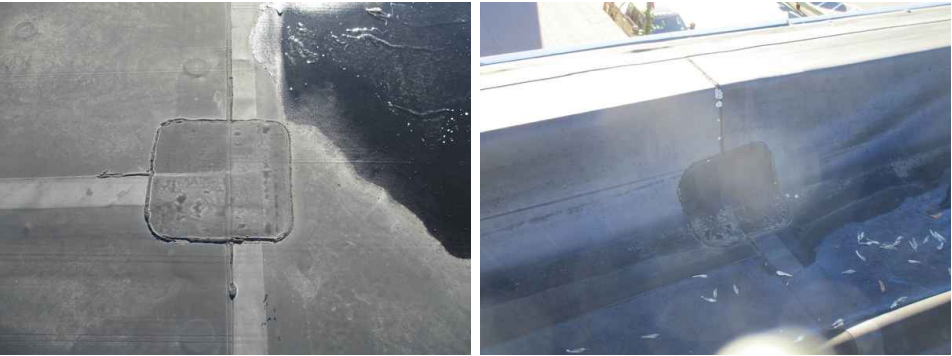
3.1.1 Coverings

Attention: The roof has been patched due to past leakage in several areas and should be monitored.

Contact a qualified roofing professional.

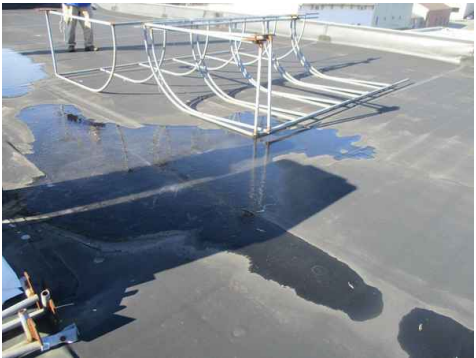
3.1.2 Coverings

PONDING

Observed ponding water in one or more areas of the roof. Ponding can lead to erosion and deterioration of the roof. Recommend a qualified roofing contractor evaluate and repair as needed.

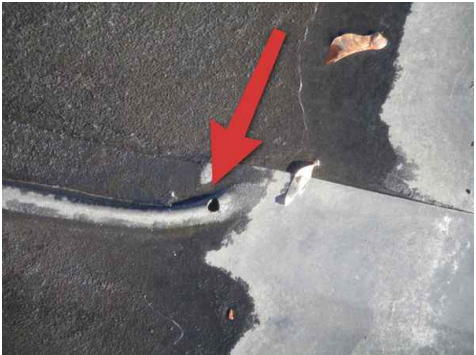
3.1.3 Coverings

HOLES IN ROOF COVERING

Correction: There are holes in the EPDM roofing material that should be patched to prevent water intrusion and damage.

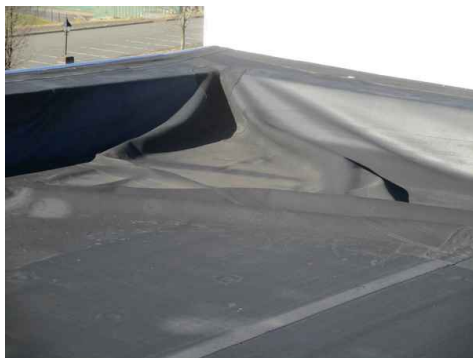
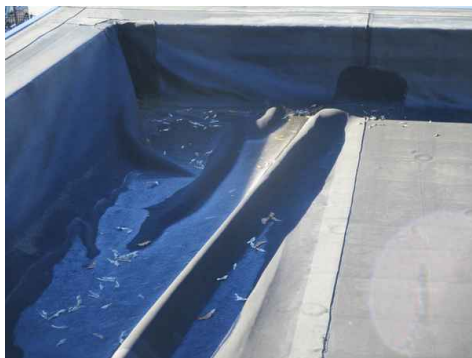
3.1.4 Coverings

EPDM ROOF COVERING WRINKLES

Correction: The EPDM roofing material has significant wrinkles in the corners of the roof. Repair is recommended.

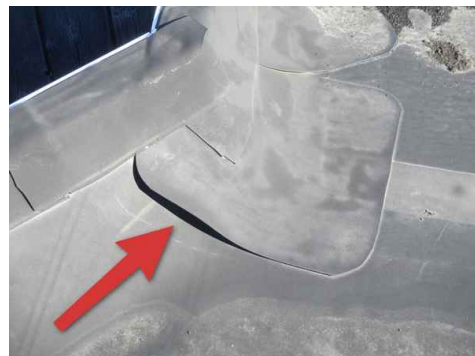
3.1.5 Coverings

LOOSE ROOF PATCH

Correction: One or more roof patches have come loose and needs to be re-sealed to prevent water intrusion.

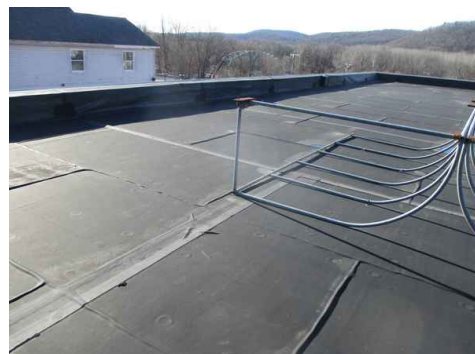
3.1.6 Coverings

DEBRIS NEEDS REMOVAL

Attention: There is debris (appears to be awning frames) on the roof that should be removed to prevent roof damage.

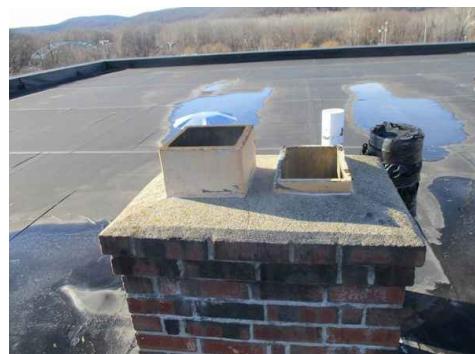
3.4.1 Skylights, Chimneys & Other Roof Penetrations

CHIMNEY CAP MISSING

No chimney cap was observed. Installation by a qualified roofer is recommended to prevent water and/or pest intrusion.

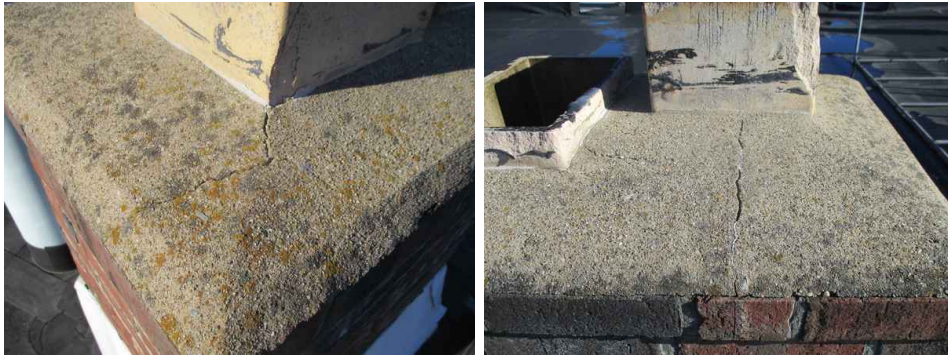
3.4.2 Skylights, Chimneys & Other Roof Penetrations

CROWN CRACKS

Correction: Cracks in chimney crown. Not correcting these cracks can lead to additional damage from seasonal moisture due to freeze and thaw.

Contact a qualified professional.

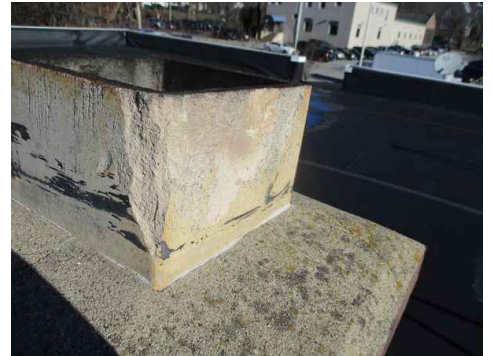
3.4.3 Skylights, Chimneys & Other Roof Penetrations

DETERIORATED LINER

Evaluate and Correct: Liner was deteriorated and/or worn. This may prevent proper draft and create build up of soot and creosote.

Contact a qualified chimney contractor.

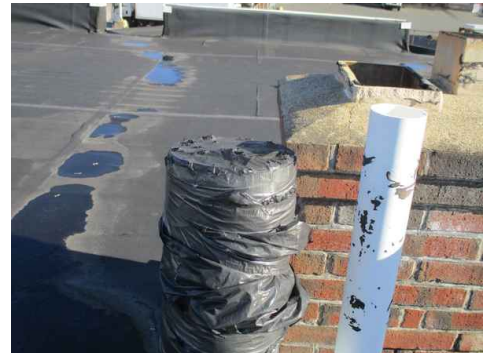
3.4.4 Skylights, Chimneys & Other Roof Penetrations

VENT COVER MISSING

Correction: There is a pipe penetrating the roof that appears to be a vent pipe that is missing a cap/cover. Installation of a cap is recommended.

Contact a qualified professional.

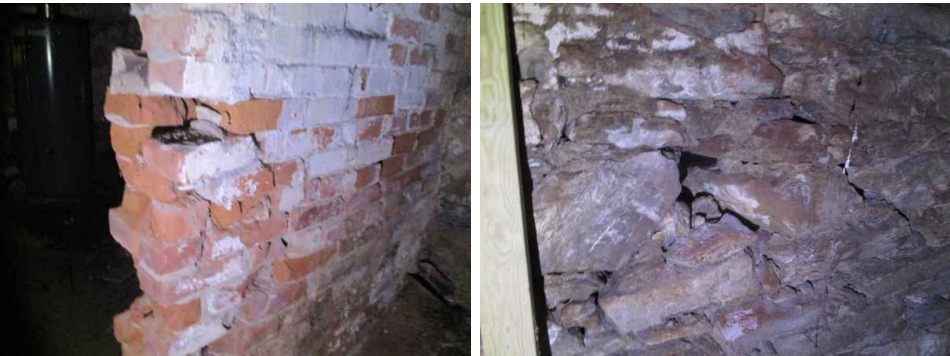
4.1.1 Foundation

Correction: Loose or deteriorated mortar joints observed. Pointing (joint repair) is recommended.

Contact a qualified masonry professional.

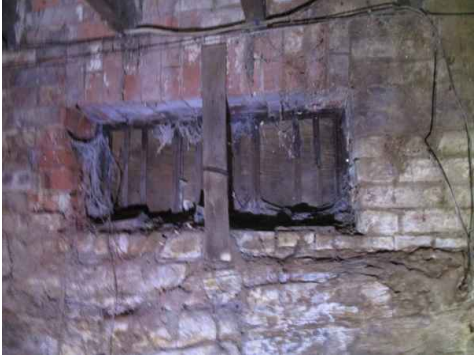
4.1.2 Foundation

OPENINGS SHOULD BE SEALED

Correction: There are inadequately covered openings at the basement foundation that should be sealed to prevent water intrusion and cold air into the basement.

Contact a qualified professional.

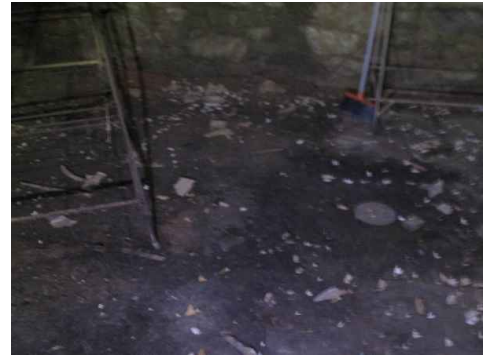
4.6.1 Moisture Issues

EVIDENCE OF RECENT WATER INTRUSION

Contact a qualified professional.

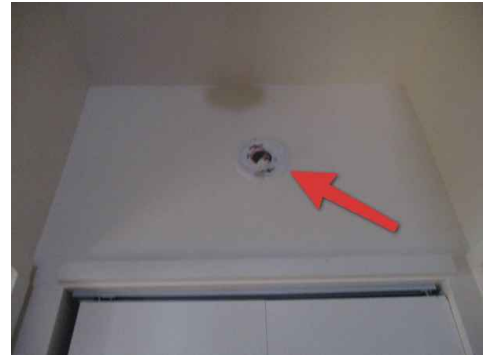
5.6.1 Smoke Detectors

DAMAGED SMOKE DETECTOR

Correction: Smoke detector was damaged or missing components and needs replacement in Unit D.

Contact a handyman or DIY project

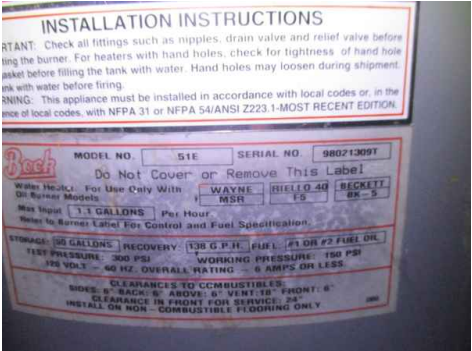
Basement

Manufactured in February 1998

I recommend flushing & servicing your water heater tank annually for optimal performance. Water temperature should be set to at least 120 degrees F to kill microbes and no higher than 130 degrees F to prevent scalding. [Here is a nice maintenance guide from Lowe's to help.](#)

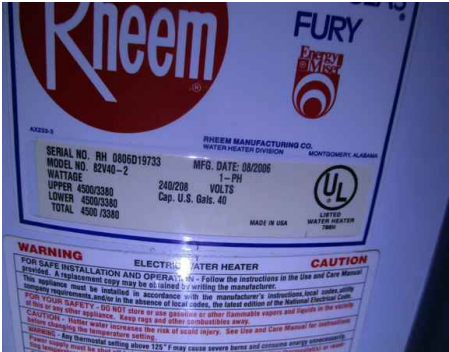
Unit A

Manufactured August 2006

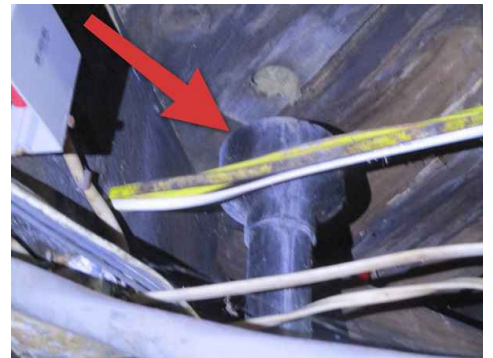
6.1.1 Drain, Waste, & Vent Systems

Correction: Open waste pipe was observed. An open waste pipe can allow sewer gasses to enter home and create an unhealthy condition. Correction is recommended.

Contact a qualified plumbing contractor.

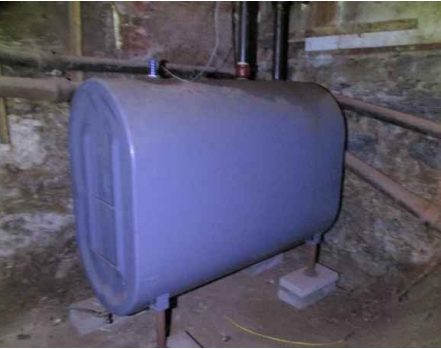
Standard Oil Report

Attention: A Standard Oil technician was present during the inspection, evaluated the HVAC system to provide additional information to the client, and issued a report. Their written report will be forwarded to client. Please refer to Standard Oil's report for evaluation and service and repair recommendations. Please call our office if you do not receive that additional report.

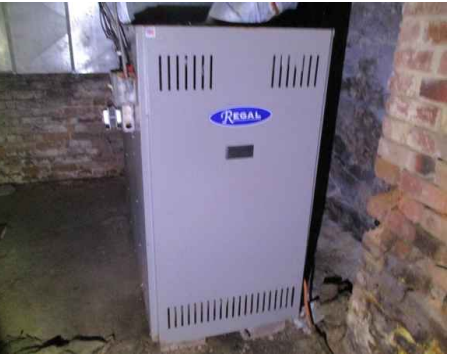
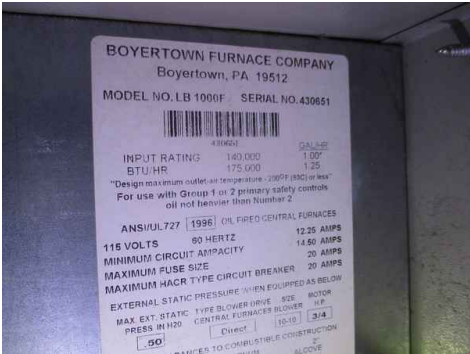
Heating Equipment Photo(s)

Energy Heat Source Electric, Oil	Heating System Type Electric baseboard, Forced warm air	Heating Manufacturer Regal
Heating Unit Age 10-15 years	Additional Comments (Heating) Heat present when thermostat turned up	Distribution Systems: Ductwork Non-insulated
Oil Supply: Oil Tank Location Basement	Oil Supply: Oil Tank Size 275 Gallons

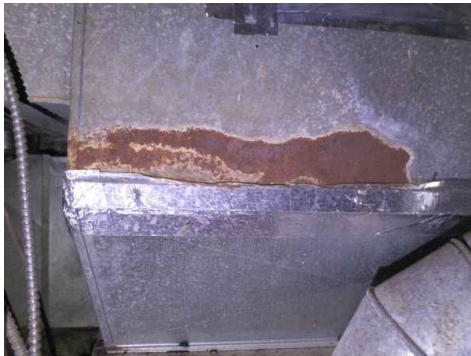
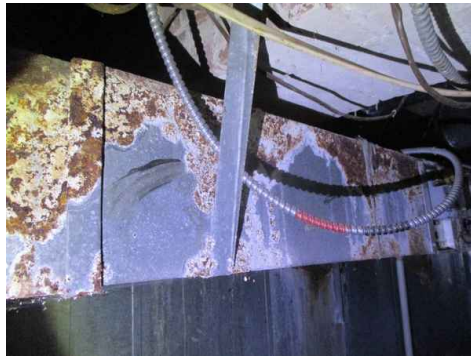
DUCTS HAVE RUST DAMAGE

Evaluate and Correct: The heating ducts in the basement have rust damage or need to have rust removed to prevent further damage. Moisture control in the basement should be considered.

Contact a qualified professional.

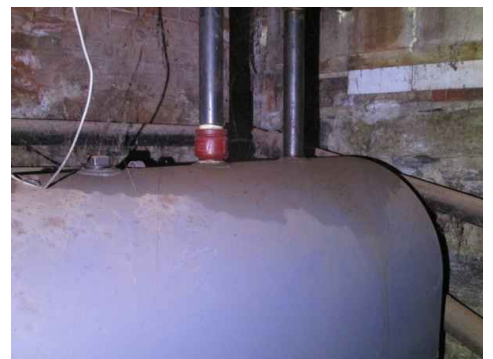
8.3.1 Oil Supply

OVERFILL STAIN

Monitor: The top of the tank around the fill and vent pipes are stained with oil. This is common, and is due to small amounts of leakage at the pipe connections. It should be monitored, and if the staining is observed to spread down the side of the tank the pipes should be resealed.

Contact a qualified professional.

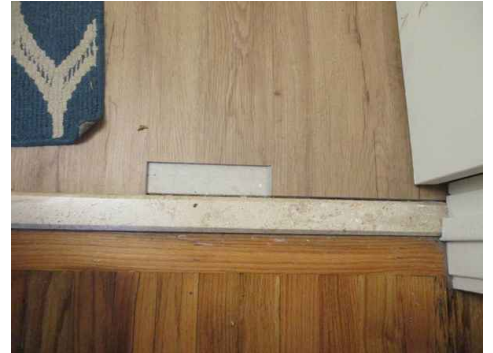
9.4.1 Floors

GAPS IN FLOORING

Contact a qualified professional.

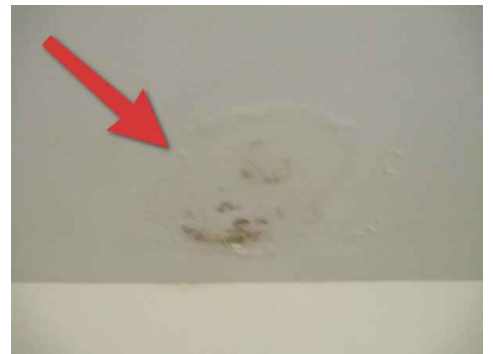
9.6.1 Ceilings

PEELING CEILING PAINT

Attention: There are areas where the ceiling paint is peeling in the bathroom of Unit C. This is most likely due to moisture. Current owner or resident should be questioned in order to obtain history of when this occurred.

Contact a qualified professional.

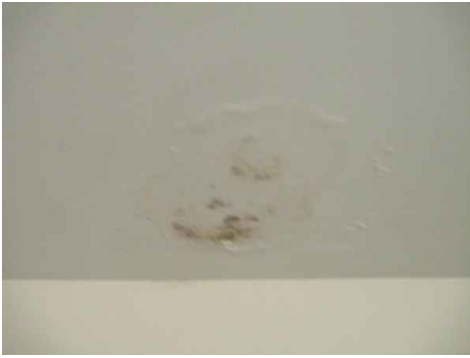
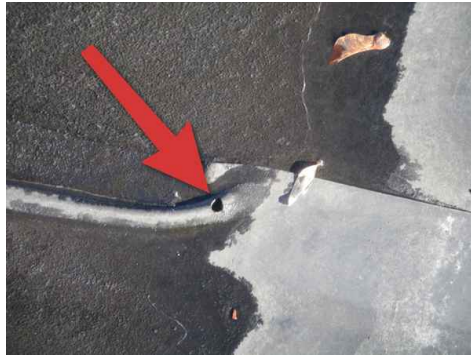
9.6.2 Ceilings

DRY WATER STAINS ROOF

Attention: Dry water stains were observed. While it is possible that the cause has been repaired and stains left untreated, this cannot be guaranteed. Current or recent rainy weather conditions may not produce actual conditions that caused these stains. If available, sellers can be questioned to obtain history; however, only further evaluation or documented proof of repair by a qualified contractor can more fully determine if the cause of the stain has been rectified. If repairs have been adequately represented the staining should be painted over with a stain killing paint and monitored.

NOTE: A hold in the EPDM roof covering was observed.

Contact a qualified professional.

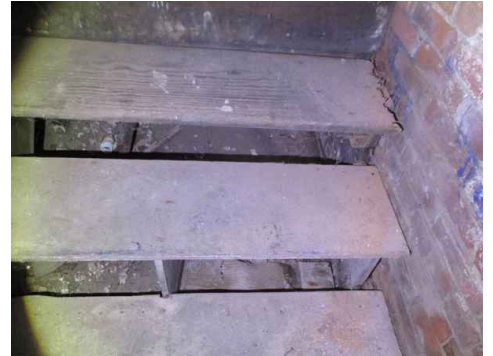
9.7.1 Steps, Stairways & Railings

STAIRS DAMAGED

Correction: The stairs to the basement are damaged and are a current safety hazard. Replacement or repair is recommended for safety.

Contact a qualified professional.
